# Manhole Inspection Summary

Manhole # S21CC2003MH

**Location** Address: **5607 MATTFELDT AVE**

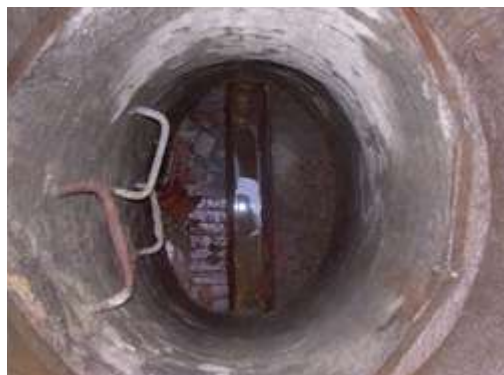
Top View

Corroded steps. Bench debris.

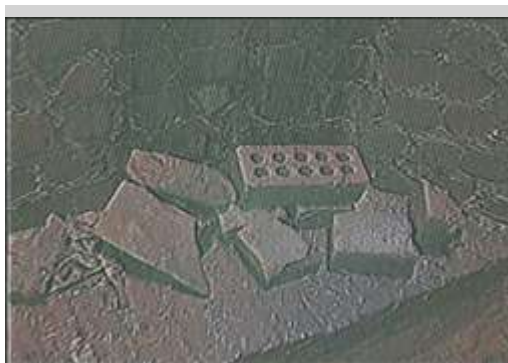
Defect

Barrel deterioration and infiltration. Bench debris.

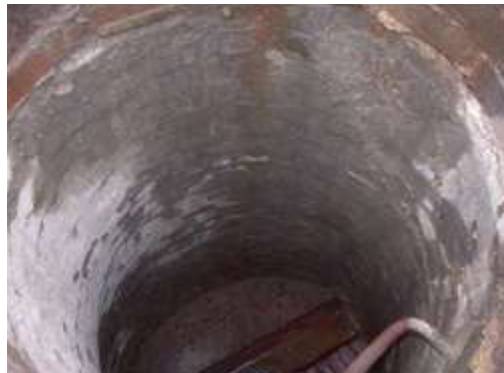
Defect

Frame leaks. Adjustment deterioration and infiltration. Barrel infiltration.

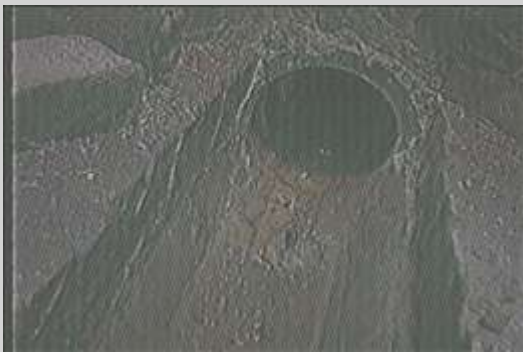
### 8 in. Circular Gravity Sewer Pipe Out @ 12 O'Clock

Infiltration: **Evidence** Pipe Seal Cond: **Cracked**

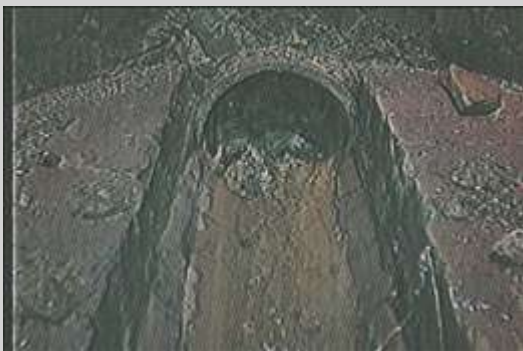
### 8 in. Circular Gravity Sewer Pipe In @ 6 O'Clock

Channel deterioration.

Deposits: ☐ None ☒ **Mud** ☐ Sludge ☒ **Debris** ☐ Grease

Silt Depth: **1** (in.) Deposits Extent: **Light**
